Report No. CG-D-28-79

STUDY OF TASK PERFORMANCE PROBLEMS IN
REPORTS OF COLLISIONS, RAMMINGS, AND GROUNDINGS
IN HARBORS AND ENTRANCES

FINAL REPORT

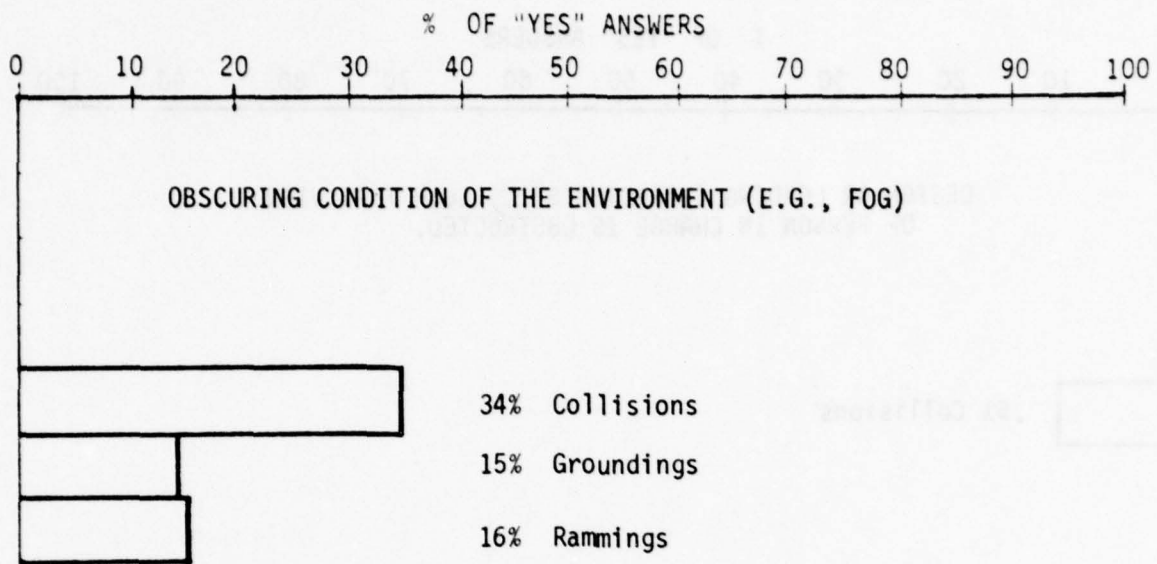
CASUALTY PRECIPITATING FACTORS - CHART 3.45

These percentages reflect answers to question VI. 34 in the R/G-CAG and question XII. 43 in the C-CAG.

Collisions	30/88
Groundings	25/154
Ramming	22/154

The natures and conditions involved in each accident type are completely different. Collisions were more apt to involve claims that vessels were unlighted, whereas the groundings cases typically involved submerged objects. (Normal shallow water was not considered in the scope of this question.)

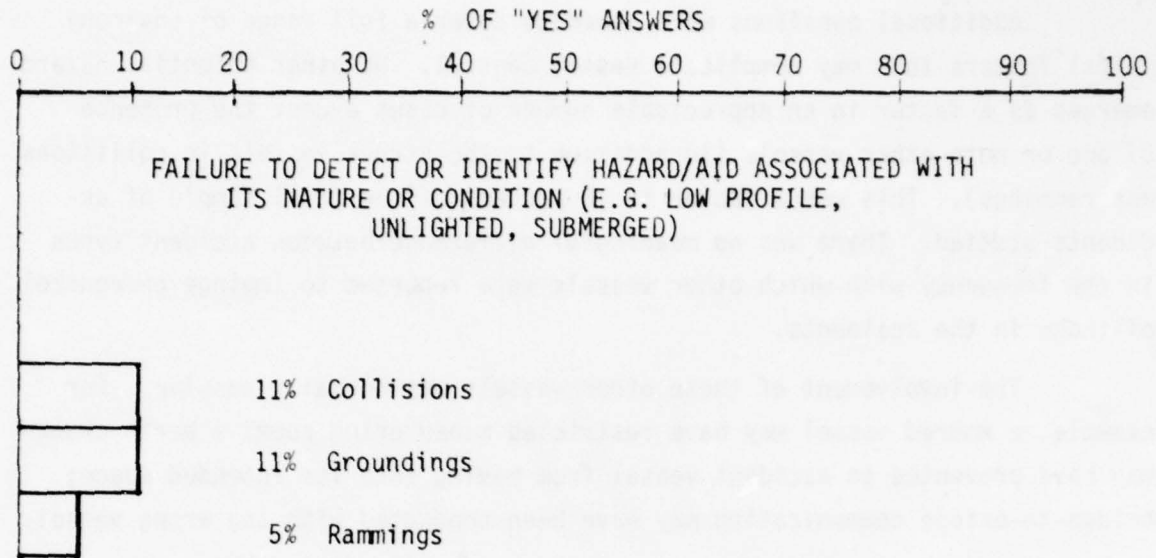
CASUALTY PRECIPITATING FACTORS - CHART 3.47

These percentages reflect answers to question VI. 33 in the R/G-CAG and questions XII. 39 and XII. 40 in the C-CAG.

Collision	4 PV only + 6 OV only = 10/88
Grounding	18/162
Ramming	7/154

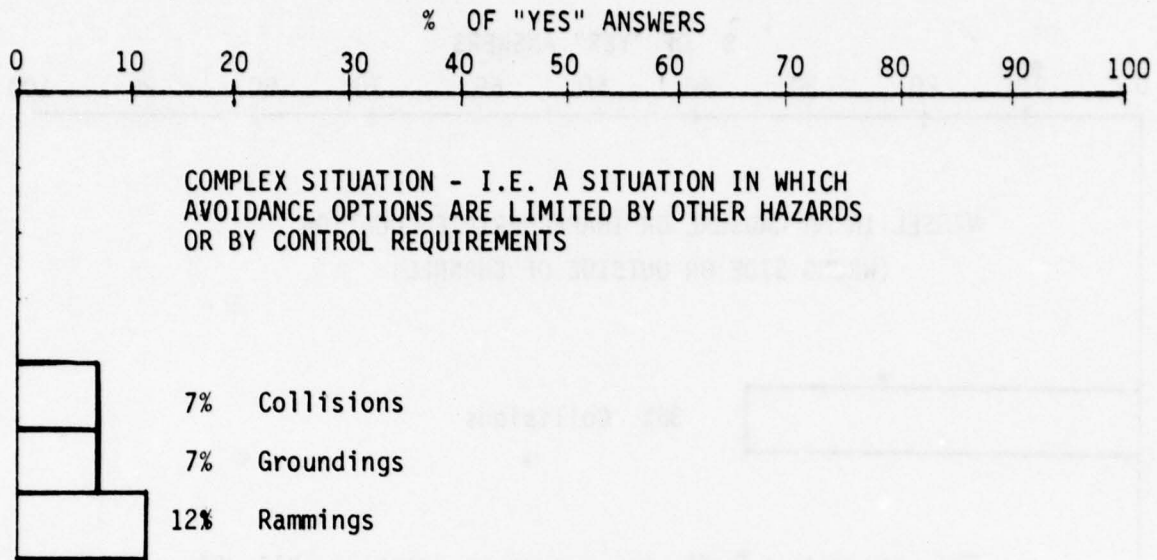
CASUALTY PRECIPITATING FACTORS - CHART 3.49

These percentages reflect answers to question VI. 49
in the R/G-CAG.

Collisions	6/88
Groundings	11/162
Ramming	19/154

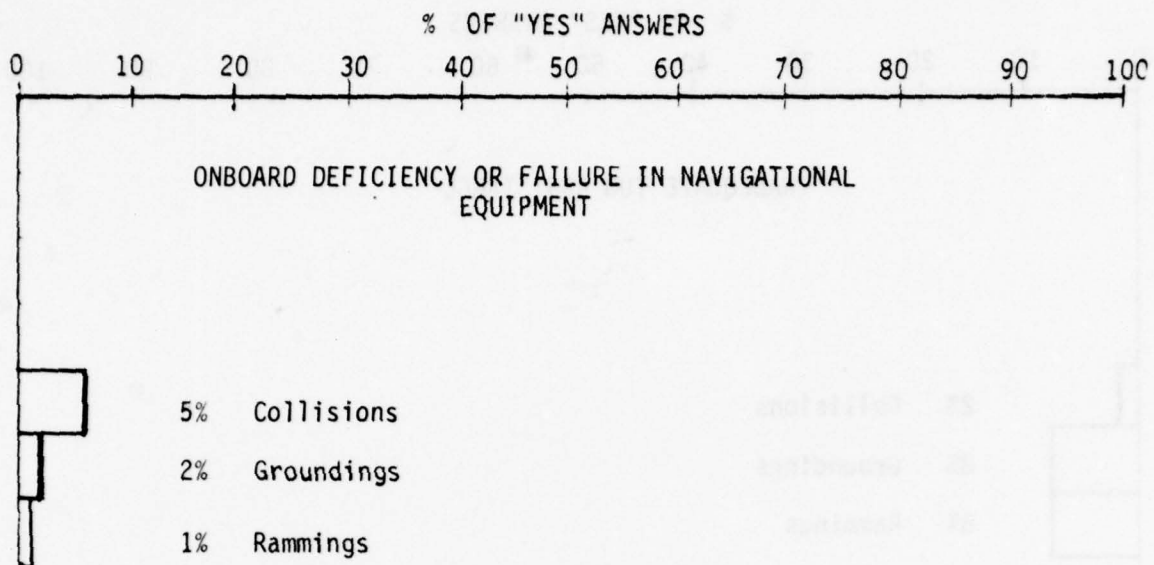
CASUALTY PRECIPITATING FACTORS - CHART 3.50

These percentages reflect answers to questions VI. 46 in the R/G-CAG and questions XII. 16 and XII. 17 in the C-CAG.

Collisions	1 PV + 3 OV = 4/88
Groundings	3/162
Rammings	1/154

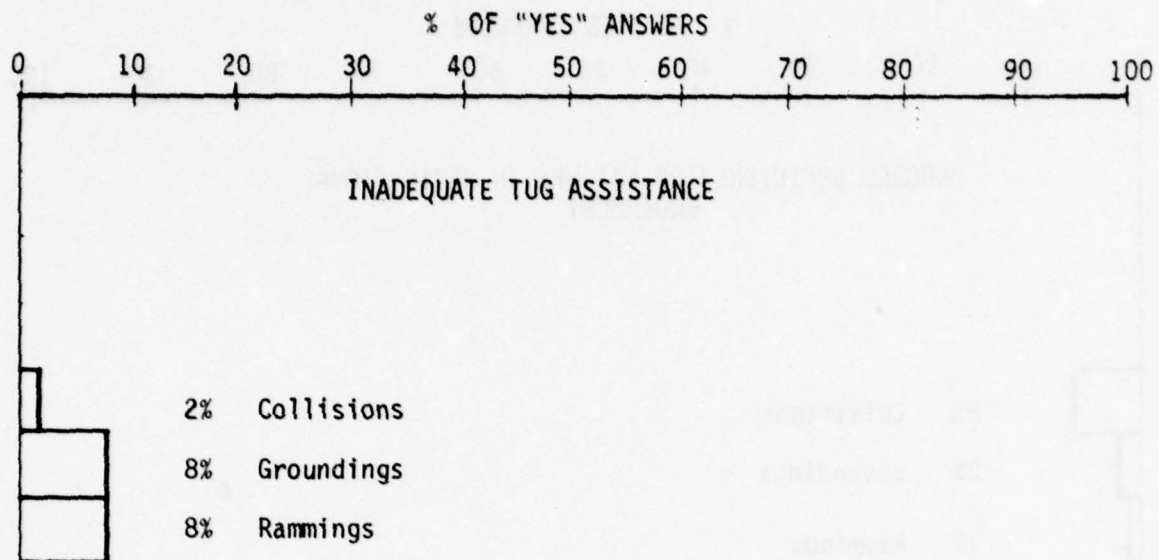
CASUALTY PRECIPITATING FACTORS - CHART 3.51

These percentages reflect the answers to question VI. 51 in the R/G-CAG and XIII. 21 in the C-CAG.

Collisions	2/89
Groundings	13/162
Rammings	12/152

Inadequate Tug Assistance (Chart 3.51). This question was only coded "yes" if a statement directed toward this topic was made in the narratives. Agreement rates on this question were therefore quite high. Either the investigating officer made this determination or the statement of the person in charge was that he could not get tugs or could not get the number he felt was needed.

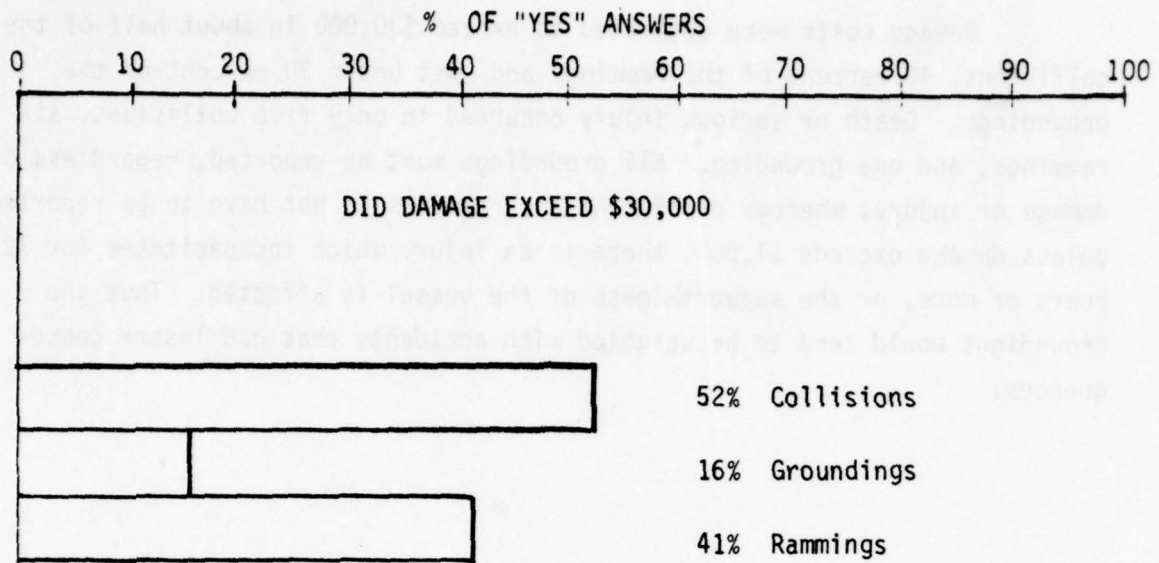
CASUALTY CONSEQUENCES - CHART 3.52

These percentages reflect answers to question VI. 53 in the R/G-CAG and XIII. 22 in the C-CAG.

Collisions	42/81
Groundings	24/151
Rammings	60/146

Damage costs were estimated to exceed \$30,000 in about half of the collisions, 40 percent of the rammings and just under 30 percent of the groundings. Death or serious injury occurred in only five collisions, six rammings, and one grounding. All groundings must be reported, regardless of damage or injury, whereas collisions and rammings do not have to be reported unless damage exceeds \$1,500, there is an injury which incapacitates for 72 hours or more, or the seaworthiness of the vessel is affected. Thus the groundings would tend to be weighted with accidents that had lesser consequences.
